# System 1\* at Agrium: Nutrient for Growth

**Fertilizer sustains world food and energy demands. At Agrium, a leading global producer and marketer of agricultural nutrients and industrial products, System 1\* is making a positive impact on operation and maintenance, helping feed the production demand.**

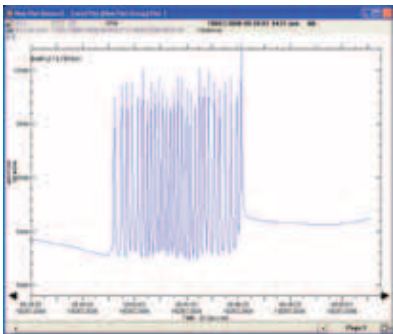
The turbine speed spiked to 10335 rpm in December 2006, above the rated trip speed.

In March 2005, the overspeed protection system on a steam turbine driven process air compressor was inspected; the trip bolt cleaned and overspeed condition tested. In December 2006, during a process upset, a maintenance engineer noticed in System 1 that the speed momentarily spiked to 10335 rpm, well above the rated trip speed of

9523 rpm. Due to slow data capture intervals, there was no indication of the overspeed condition in the DCS. The overspeed protection trip bolt didn't act. The maintenance engineer alerted operations of this anomaly. At the next available outage in June 2007, the trip bolt parts were examined, and were found to be contaminated with thick, sticky sludge that prevented the mechanism from functioning properly. Thorough cleaning and testing ensued and the steam turbine was overspeed

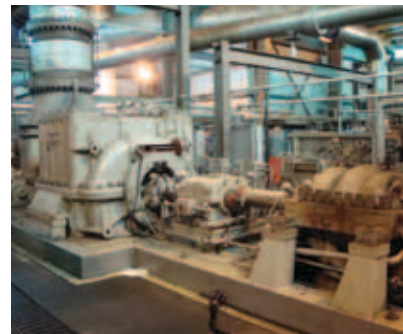
Process air compressor, compressor train.

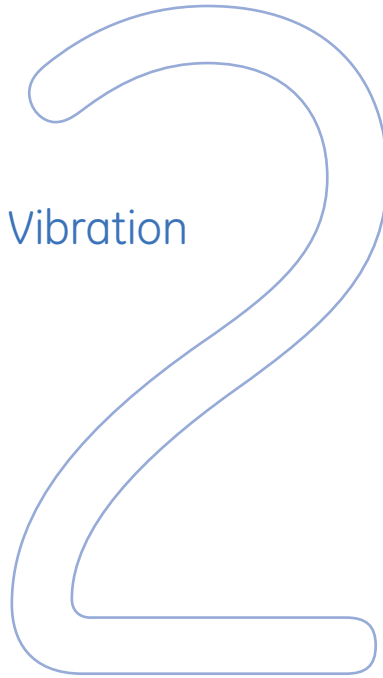
The maintenance engineer uncovered another malfunction of the steam turbine in case history #1 in February 2006. After an outage, the radial vibration on the exhaust bearing step-changed from about 40 micron to 60 micron, and then went as high as 80 micron occasionally. During the outage of June 2007, the turbine was run solo as part of the overspeed test. The shaft centerline plot from the solo test rundown was compared to that of the coupled rundown before the outage, and distinctive differences between the shaft centerline movements and vibration levels were observed. It was concluded a significant component of the vibration was caused by internal and external misalignment. Turbine alignment keys and supports were lubricated with Molykote® 321 in June 2007, and vibration decreased from 60 microns to 50 microns. In the outage of July 2008, the plant replaced the coupling and re-aligned the turbine and compressor. After the outage, vibration dropped and settled out at 40 microns. As explained by the maintenance engineer, “System 1 allowed us to see dynamic response of the turbine in real time. Although the 40-micron level is higher than desired, it is acceptable, but the 80-micron level is just a step away from a shutdown and overhaul. The potential consequence of such a failure would be an unplanned outage at \$5 million lost production. Even if the probability of this failure were 1 in 10, from this single incident we saved \$500,000.”

Vibrations were around 40 microns prior to February 2006 outage; the vibration jumped to 60 microns on the start up and went as high as 80 microns.

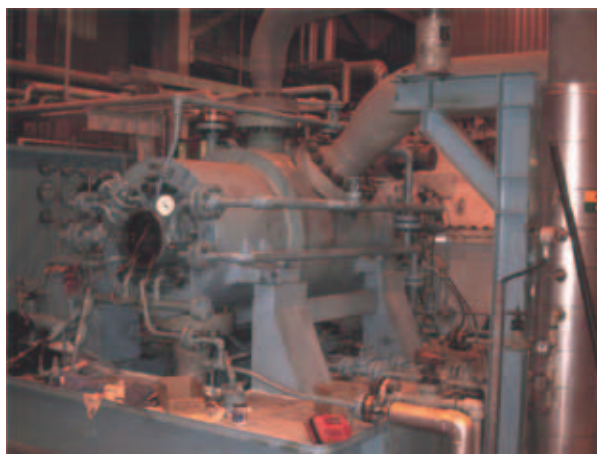
**3** Joffre Nitrogen Operation produces 480,000 tons of ammonia per year. The heart of the process is synthesis gas compressor. The thrust bearings in the compressor high-pressure case are furnished with proximity probes and embedded temperature probes. At the beginning of November 2008, an apparent upward trend of bearing temperature was noticed at the inboard thrust bearing, but the outboard bearing temperature remained stable. In the previous three months, the inboard bearing temperature increased from 90C to 120C. During the same time period, the axial position measured at the inboard bearing only moved 3 mils. The orbit-timebase plot for inboard radial bearing vibration was examined and no distinct changes noticed.

The plant maintenance technician was concerned about possible thrust bearing damage, so an outage was planned. On November 17, 2008, the compressor was shut down. The inboard thrust-bearing pads had over 0.020 inch Babbitt removed from the trailing edge and were down to the steel backing. The root cause was electrostatic discharge. Consequently, grounding brushes were repaired and a back up brush installed. Since then, it has kept the problem from re-occurring. In this case, the plant maintenance team shut down the compressor on the strength of both System 1 data and DCS data. The damage was limited to only the thrust bearing and no other rotating or stationary parts were affected. The maintenance cost of the planned outage was minimized compared to emergency shut down at an inopportune time. System 1 saved the plant a potential loss of \$250,000.

It is intriguing to note that the thrust movement, less than 5 mils, was far less than amount of the thrust bearing pads erosion, over 20 mils. Electrostatic damage showed up predominantly as a bearing temperature excursion. The change of bearing temperature was more indicative of damage than that of bearing axial position.

Synthesis Gas Compressor, High Pressure Case.
